CALSPAN ON-SITE AIR BAG DEPLOYMENT INVESTIGATION

CALSPAN CASE NO. 96-02

VEHICLE #1 - 1995 ISUZU TROOPER (AIR BAG EQUIPPED)

VEHICLE #2 - 1986 BMW 325 ES

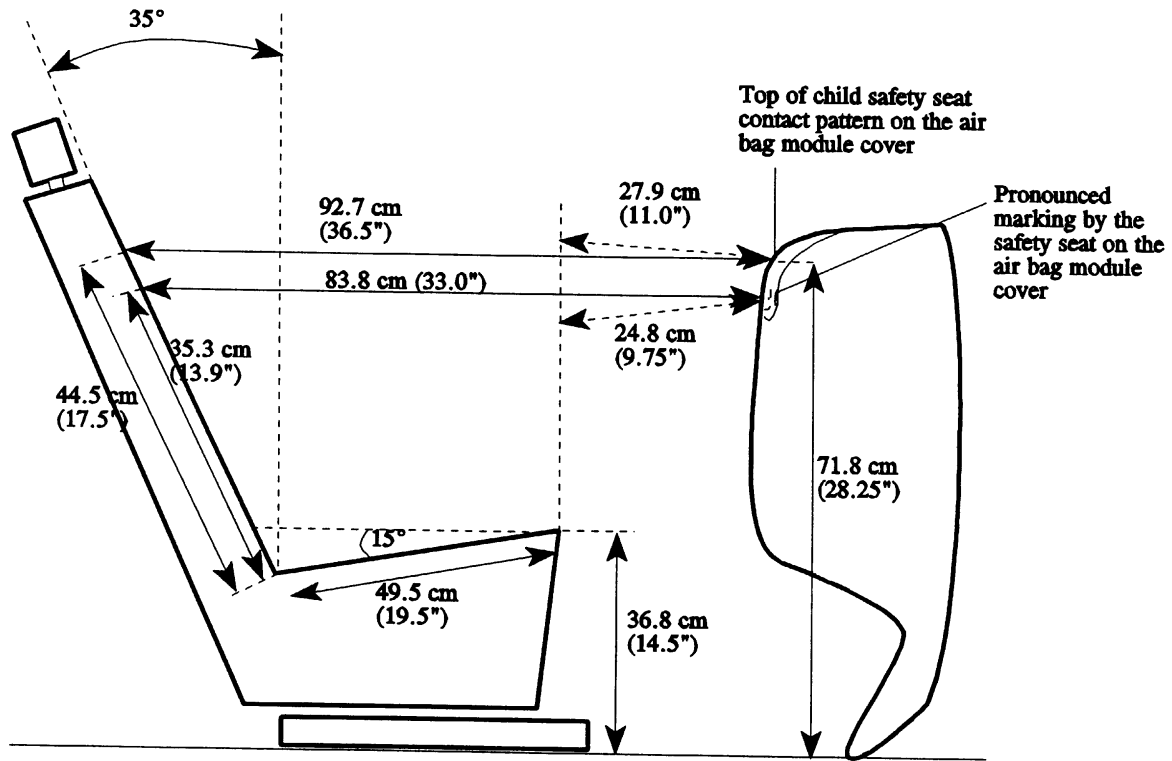
Right Front Passenger Seat Longitudinal Location With Respect To The Air Bag Module Cover

The seat was in the full rear adjusted position at the time of the inspection which appeared consistent with the position noted in on-scene police photographs. The seat track had an adjustment range of 18.0 cm (7.1"). When the seat was adjusted on the seat track to the specifications of the FVMSS 208 test, the seat back rest measured a horizontal distance of 64.8 cm (25.5") to the air bag module cover and 82.6 cm (32.5") to the rear seat cushion.
